## Upper Thomas Fork Creek Stream Bank Stabilization Projects

## Kinsey Corral Relocation and Riparian Fencing Project

## Perrine Coulee Irrigation Return Flow Settling Ponds and Wetlands Projects

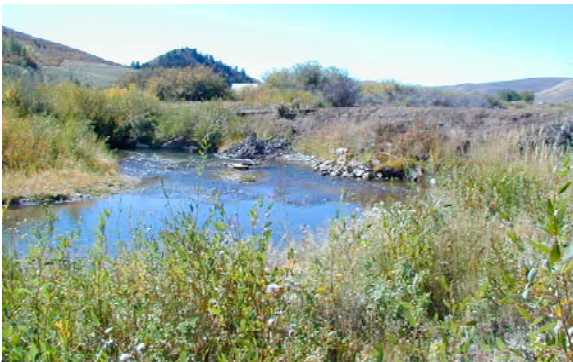
Construction was initiated and completed during the fall of 2003, along 100 linear feet of degraded riparian area. Treatments applied at this location include: rip-wrap, toe armor, three bank barbs, willow cuttings, reseeding, and sedge plugs. Most of the techniques implemented are in excellent condition. Willow plantings and sedge grass plugs are in poor condition or non-existent. Other improvements employed at this segment were the removal of existing (unapproved) stabilization practices. Three cars were removed from their placement along Thomas Fork Creek as erosion control many years ago. These treatments were removed from the stream and transported to a more appropriate location. Photos were taken before and after rehabilitation (Figure 38, Figure 39).

Figure 38. Segment 2 prior to treatment with BMPs.

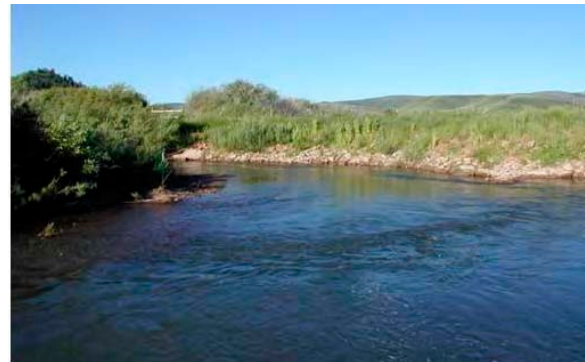
Figure 39. Segment 2 after treatment with BMPs.

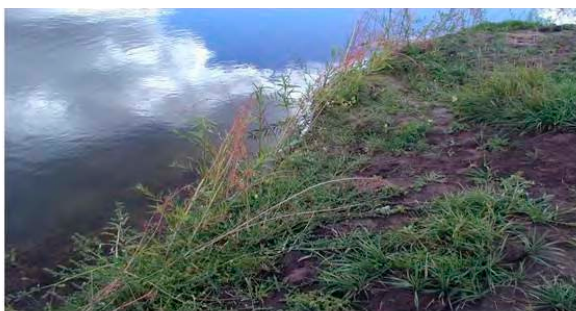
**Figure 40. Success of willows planted in July (photo taken one month after planting).**

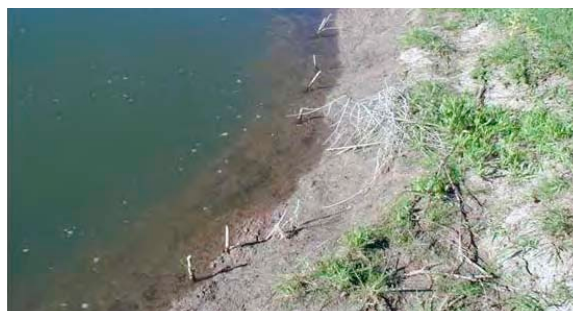
Treatments applied along 100 linear feet at segment seven provided results contrary to convention. Treatments included bank shaping, willow planting, and reseeding. Willows were planted during July, which is contrary to popular convention; leading science suggests that willow regrowth is maximized when planted in early spring or late fall when plants are dormant. One month after planting, nearly 100% of those plantings were alive and healthy (Figure 40). Grass seed spread approximately the same time was also growing in abundance. One year later, nearly all of the willows are gone. Ninety-eight (98) percent of those still at the site have produced new growth and appear healthy. However, many of these same plants were either consumed or hauled away by beavers (Figure 41).

**Figure 41. Segment 7 willow plantings after one year.**

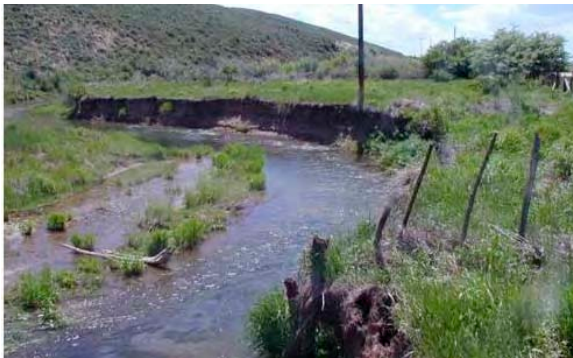
Treatments along this segment of highly eroded stream bank (Figure 42) include: bank shaping, rip-wrap, grass seed, and two bank barbs. These treatments were applied along 400 linear feet of stream bank to stabilize the channel meandering toward US highway 89. All of these treatments are in excellent condition (Figure 43). Willows were not planted at this location. Unsuccessful results at upstream locations were cause for not using this treatment at this location.

**Figure 42. Segment 11 before treatment with BMPs.**

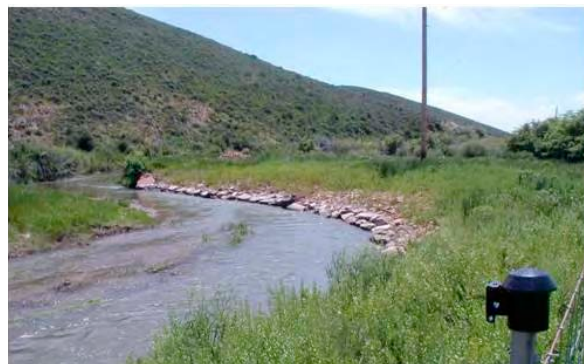
**Figure 43. One year after implementation of BMPs, Segment 11.**

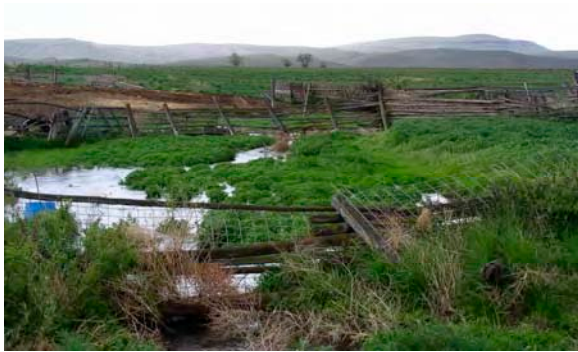
Figure 44. Corrals built directly on McMullen Creek before cleanup.

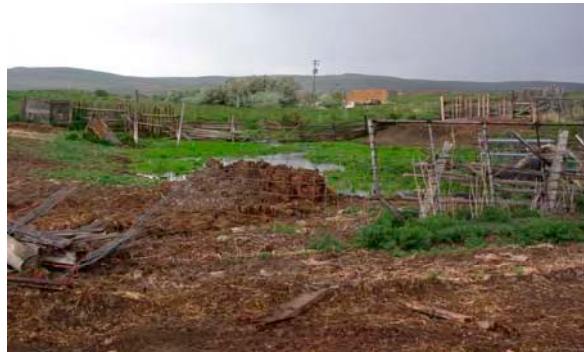
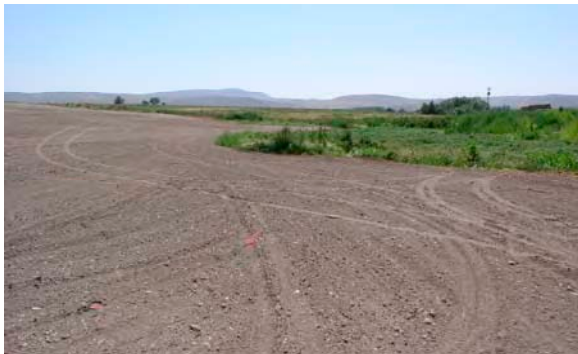
Figure 45. Kinsey Corral: old corral site after cleanup.

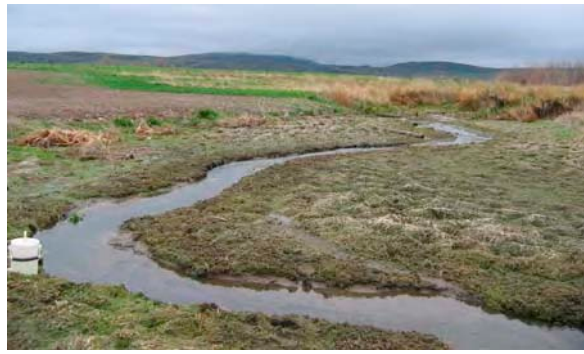
Figure 46. Kinsey Corral: riparian area after cleanup.

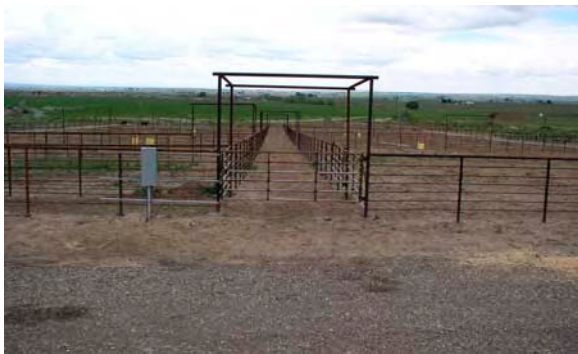
Figure 47. Kinsey Corral: new corrals rebuilt one mile away from McMullen Creek.

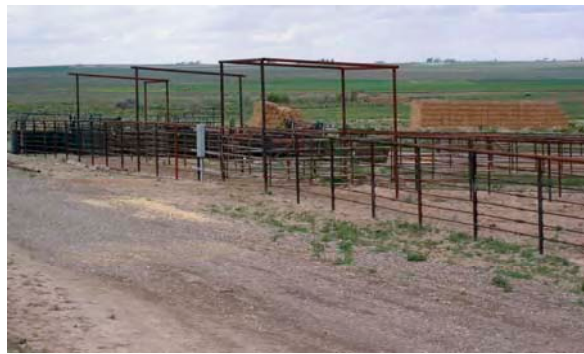
Figure 48. Kinsey Corral: another view of the new corrals.
